Presented by: A K Pandey DGM (F&S)
IFFCO Aonla Unit, Bareilly

2b Tank T-2301 technical details

7a- Glimpses of NDT tests carried out inside the Tank-2301

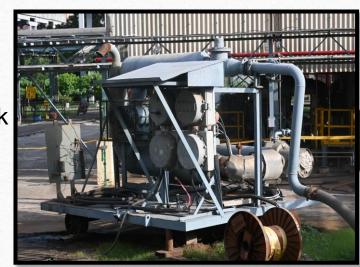
After oil reclaiming and cleaning of tank floor and side walls from inside, the concentration of ammonia found around 300 ppm. For carrying out visual inspection entry without respiratory equipment is needed but the ammonia concentration was not reducing below 300 ppm.

- Vacuum blower provided at one end placed in centre of tank to suck air from top manhole and remove through blower vent.
- Spraying fine water spray inside the tank using fire water hose and nozzles to dilute the ammonia inside tank to further decrease the concentration of ammonia gas.

After following these methods, drastic reduction in ammonia concentration found from 300 ppm to around 25 ppm in different samples. Man entry without airline mask was permitted for carrying out NDT test.

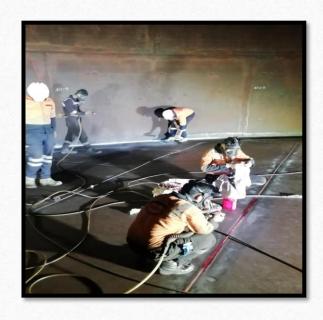
Visual inspection & DPT

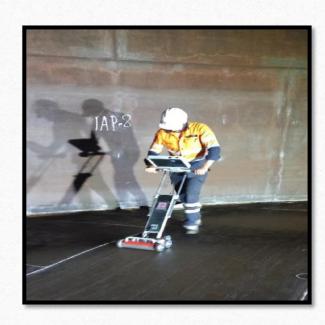
MFL testing

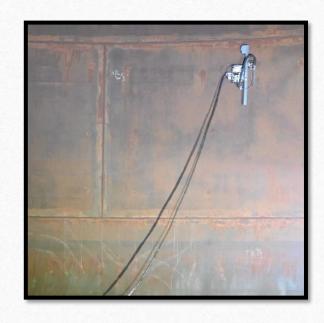
Corrosion mapping test
