# SAFE EXECUTION OF INFRA PROJECTS

**Engineer's role and responsibility to strengthen EHS (Environment, Health & Safety)....**

**Rajesh Prasad**  
Director Operations, RVNL

### Rail Vikas Nigam Limited (RVNL)

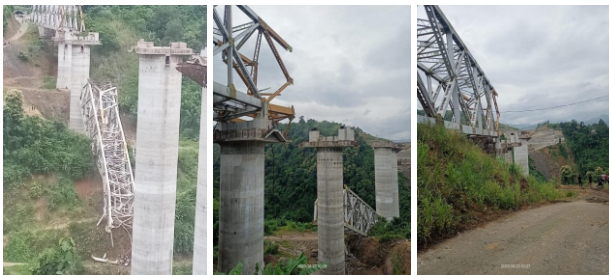
### Under construction Railway Bridge collapses near Sairang, Mizoram (N. F. Rly.) – 23.08.2023

**(17 persons died on the spot)**

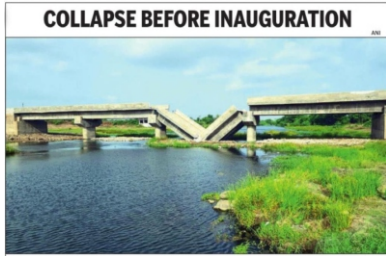
A span of a newly built bridge on Mindhola river in Tapi district, Gujarat collapsed on 14.06.2023

A bridge over the Mindhola river connecting Majpur and Degama villages of Gujarat's Tapi collapsed before its inauguration on Wednesday. No casualties have been reported from the site

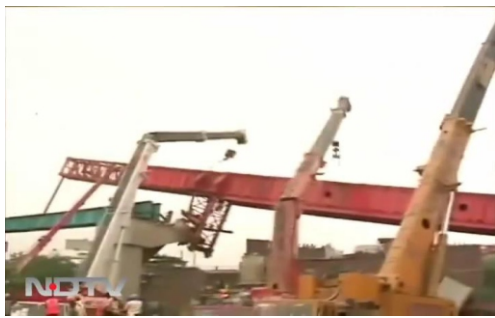
Zamrudpur Metro worksite accident

'L' pier gave enough warnings....

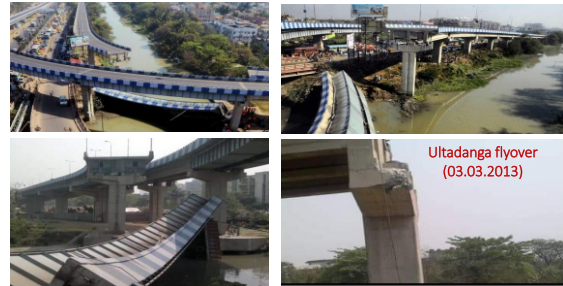
Sequencing in construction is very important Placements of wrong bearings...

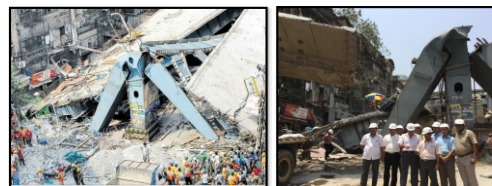
Restoration work of Vivekananda Flyover by RVNL

Vivekananda Flyover under construction by KMDA, Govt. of West Bengal. Suddenly collapsed on 31.03.2016

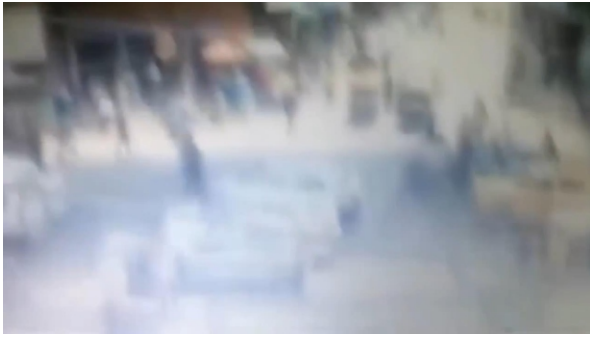
IIT KGP REPORT- DEC 2017

- Poor Contract
- Poor Design
- Poor Workmanship
- Poor Supervision

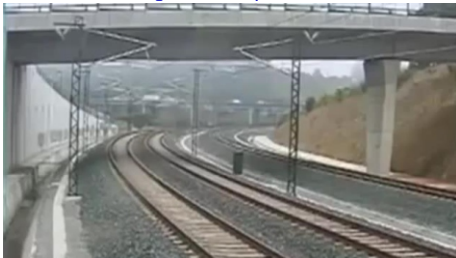
**Derailment of Santiago de Compostela Train Crash - Spain**

**Spain disaster: Train jumps off the tracks on approach to north-western city of Santiago de Compostela Spain killing 80 Passengers**

European Rail Traffic Management System (ERTMS) is normally available for High Speed route to take care of such eventuality. In this case it was about to be provided in next few days. The conventional system AFSA by Dymetronics was discontinued only few days back and the new system ERTMS was not in place. The driver was under pressure to reach destination within the permitted time and Technology was not there to check and control. It seems to be Human Error with System Failure and gives a feeling as if it had happened in India.

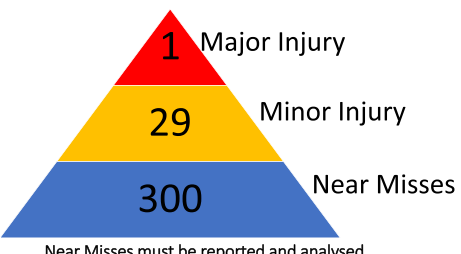
**Heinrich 300-29-1 Model**

1 Major Injury  
29 Minor Injury  
300 Near Misses

Near Misses must be reported and analysed...

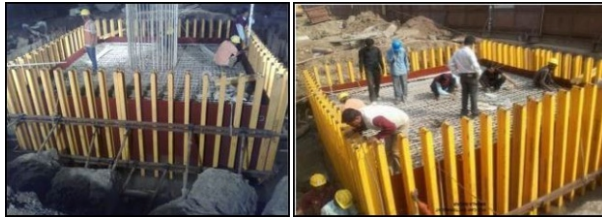
**Protection of worksite... (Pile Cap work)**

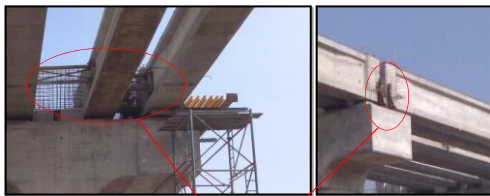
STEEL FRAME LOCKING ARRANGEMENT

**I-GIRDER STEEL FRAME LOCKING ARRANGEMENT**

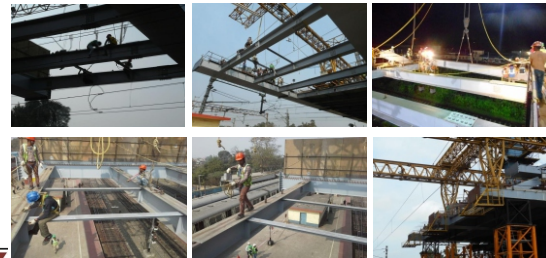
**Safe work practices adopted during erection at cable stayed bridge site by RVNL**

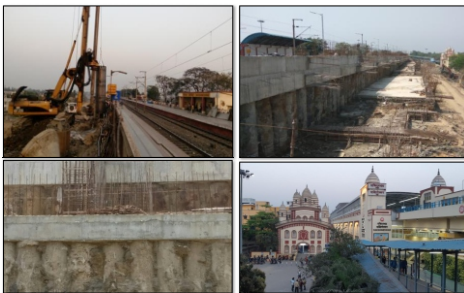
**DAKSHINESWAR STATION**

How the PFs were protected with contiguous piles....

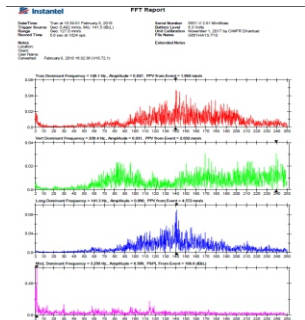
**Monitoring System at tunnel site**

The summary of blast vibration and Fast Fourier Transform Analysis (FFT)

PPV = 4.572 mm/s < 10mm/sec.

Noise = 106.0 dB < 146 dB

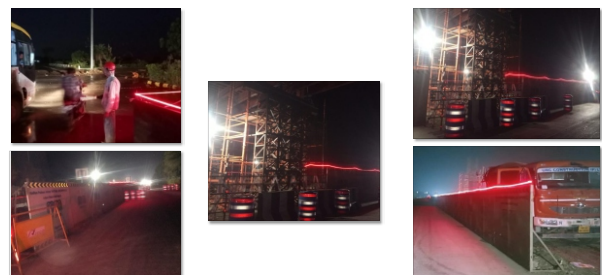
**Safety arrangement for Night work by RVNL**

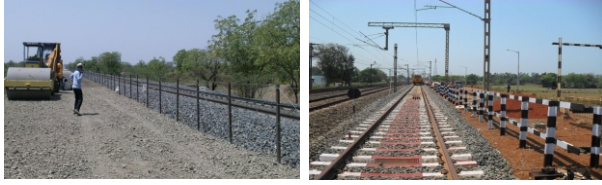
### SAFE EXECUTION BY THE SIDE OF TRACK

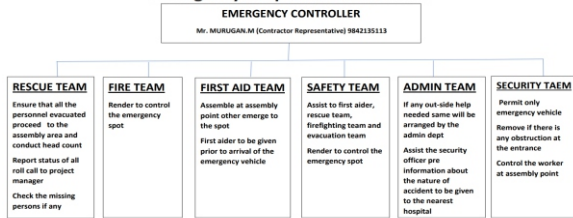
#### Emergency Response Control Plan

Note:  
INCIDENT SPOT CONTROLLER: Give the correct information about location & nature of emergency to project manager (Emergency controller)  
EMERGENCY CONTROLLER: Approve the evacuation procedure & location of assembly area determine whether there is need for evacuation. Order to activate alarm ALL PERSONEL Stop the work & evacuate safely to assembly point. Assemble according to work area wait for the instruction from supervisor or Engineer

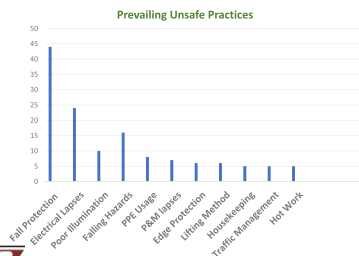
### Analysis Of Unsafe Act/Conditions For The Month Of Aug 2023

1	Fall Protection	44
2	Electrical Lapses	24
3	Poor Illumination	10
4	Falling Hazards	16
5	PPE Usage	8
6	P&M lapses	7
7	Edge Protection	6
8	Lifting Method	6
09	Housekeeping	5
10	Traffic Management	5
11	Hot Work	5
	<b>Total</b>	<b>136</b>

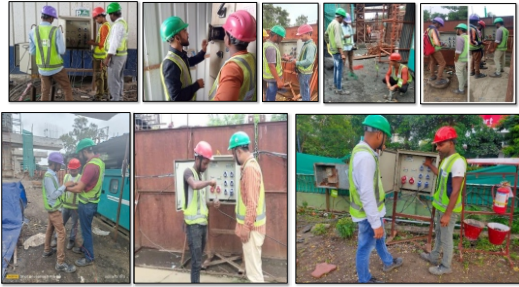
### Electrical Equipment Inspection

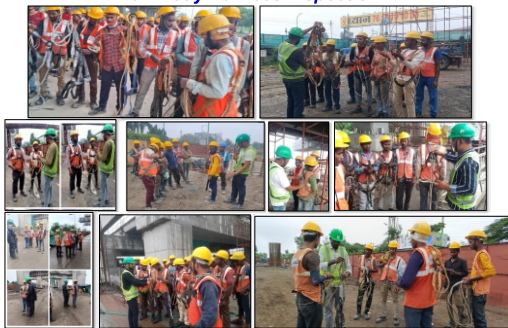
### Full Body Harness Inspection

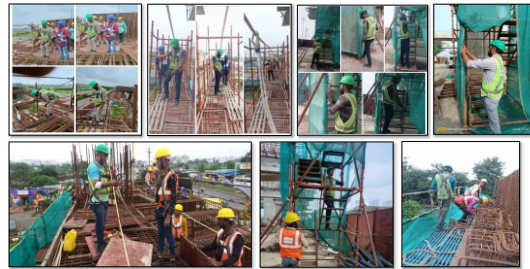
### Work At Height Inspection
