Indian Farmers Fertiliser Cooperative Ltd. Aonla Unit

Safety Measures Taken During Decommissioning and Recommissioning of Ammonia Storage Tank T-2301

– A K Pandey, V K Shrivastava &
Neeraj Rajesh

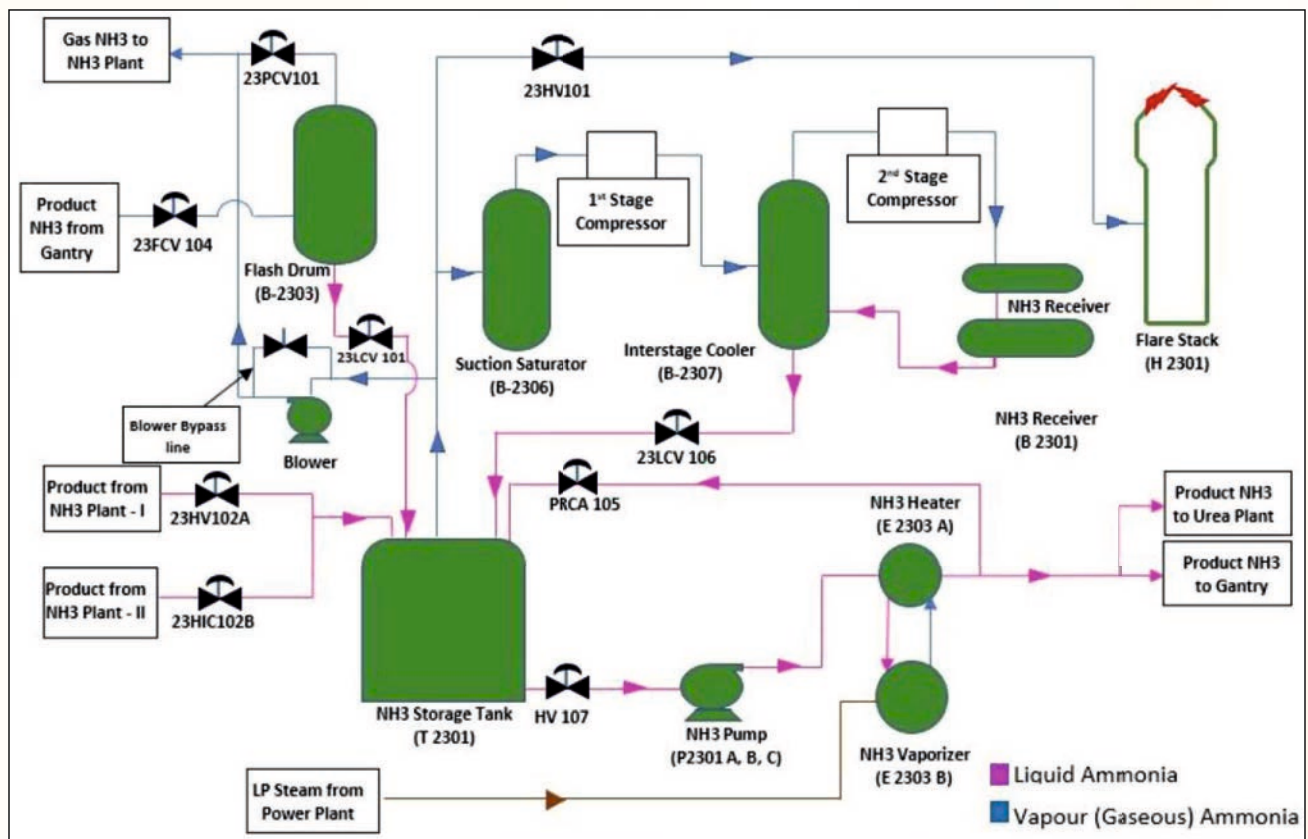
Under normal operating conditions, the ammonia storage tank maintains a pressure range of 450±150mmWC. If the pressure exceeds 750mmWC, HIC-101 will open to direct ammonia vapor from the tank to the dedicated flare stack. Each tank has its separate flare stack for safety measures. When the pressure reaches 1050mmWC, the Ammonia storage tank's Pressure Safety Valve (PSV) will open to release ammonia vapor into the atmosphere, ensuring that the pressure remains within safe limits.

On the other hand, when the pressure starts to reduce and reaches 250mmWC, the refrigeration process will be halted. At 200mmWC, PRCA-105 will open, allowing hot ammonia to flashback into the tank. Moreover, when the pressure drops to a range of -26 to -30mmWC, the vacuum breather will open to intake atmospheric air into the tank, stabilizing the pressure. These pressure control measures are vital for the safe and efficient operation of the ammonia storage system, preventing potential hazards and ensuring the integrity of the equipment.

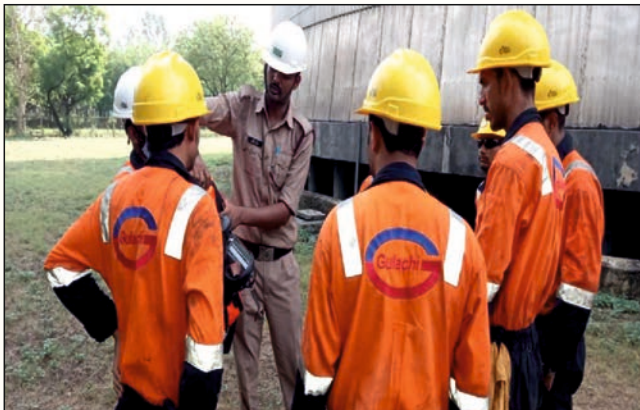
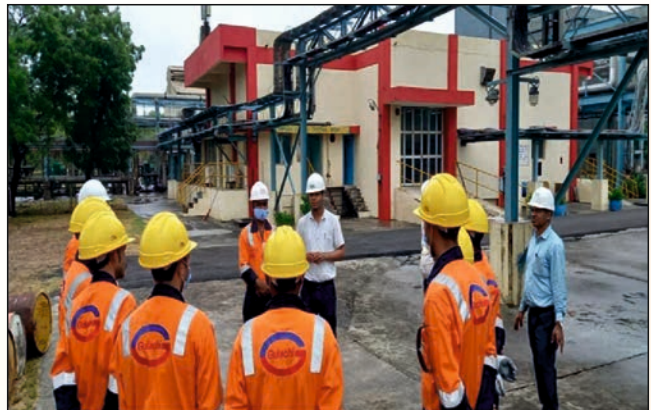
Confined space entry Safety

A handwritten log sheet titled "Confined Space Entry Log Sheet" with columns for "Time", "Location", and "Personnel". It contains a list of activities and times, such as "10:45" and "11:30", and names of workers and supervisors.

A printed "ROPE ACCESS PIPE'S CHECKLIST" form. It includes fields for "Contractor", "Address", "Class", "WD No", and "Project". The main table has columns for "Description", "Okay", "Not Okay", and "Remarks". It lists various safety checks such as "Checking the condition of the ropes", "ASAP LOCK", "FD, FDI, TD, EVAC and RIG", "Professional Harness", "Safety Harness", and "Others".

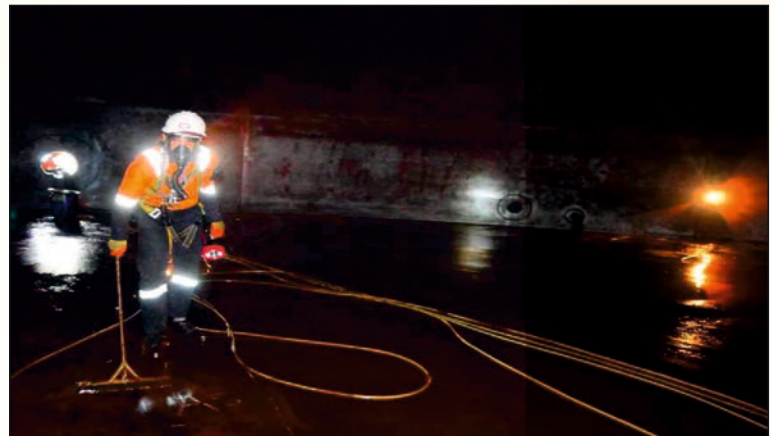
Safety training & instructions given to contract workers about hazards and safety

Airline masks used for continuous respiration along with PPE dress to avoid possible skin contact with ammonia vapour

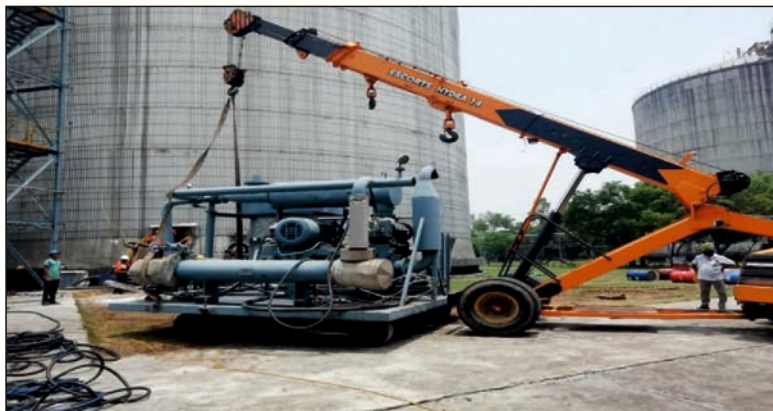
After cleaning the inside of the tank, the concentration of ammonia was found to be around 300 ppm. To Confined space entry and carry out reasonable visual inspection without respiratory equipment, the ammonia concentration needs to be reduced below 300 ppm. Therefore, innovative measures were taken to achieve the vacuum in the inner tank, a vacuum blower was placed outside the tank, with one end placed in the center of the inner tank to suck air from the top manhole and expel it through the blower vent into outside.

Fine water spray was applied inside the tank using the fire water hose and nozzles to remove the residual ammonia and to further decrease the concentration of ammonia gas in tank, to provide ammonia free atmosphere As low as reasonably practicable (ALARP) to start the inspection effectively and without any ill health effect.

After implementing the fire water spray, a significant reduction in ammonia concentration was observed, dropping from 300 ppm to approximately 25 ppm in different samplings. Subsequently, personnel were permitted to enter the tank without an airline mask to conduct the NDT (Non-Destructive Testing) tests effectively, which were found to be normal and within permissible limits.

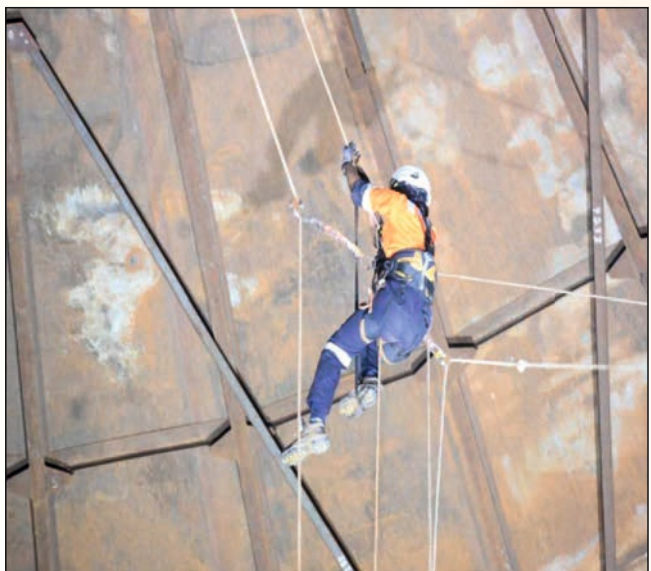
Roof inspection using Rope Access gears.

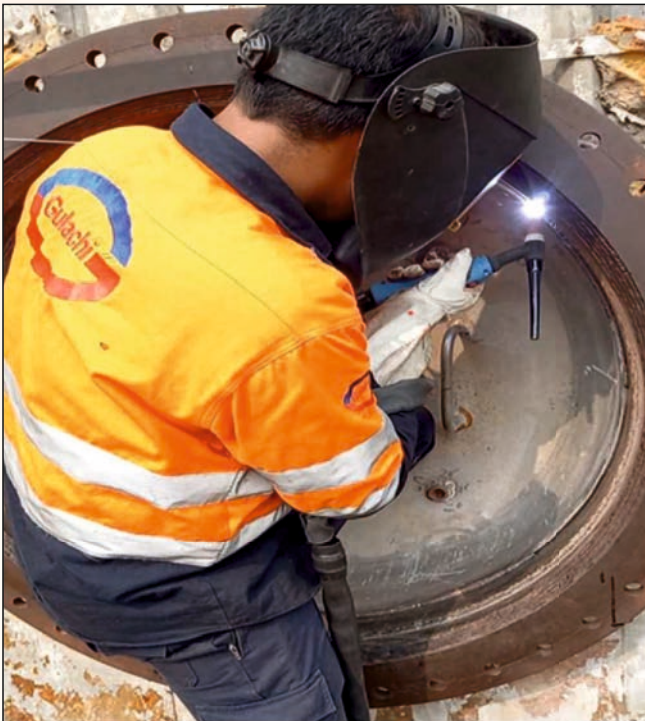
Tig welding of manway

Rewelding of Inner and Outer tank convex Manway was carried out. After Man ways, covers including Roof and Shell Manways was sealed using SS spiral wound gasket.

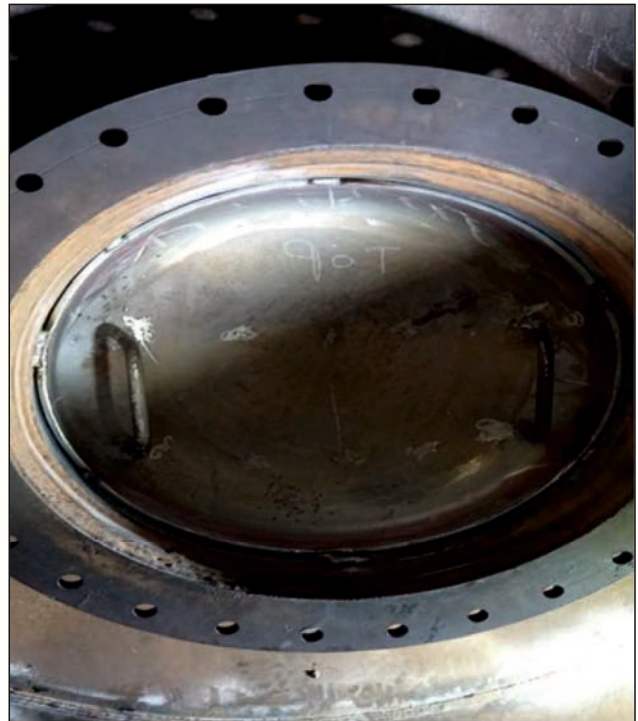
Fit up after welding.
